SLATTERY LAKE DAM

LOUDOUN COUNTY, VIRGINIA

VA. NO. 10710

# PHASE I INSPECTION REPORT

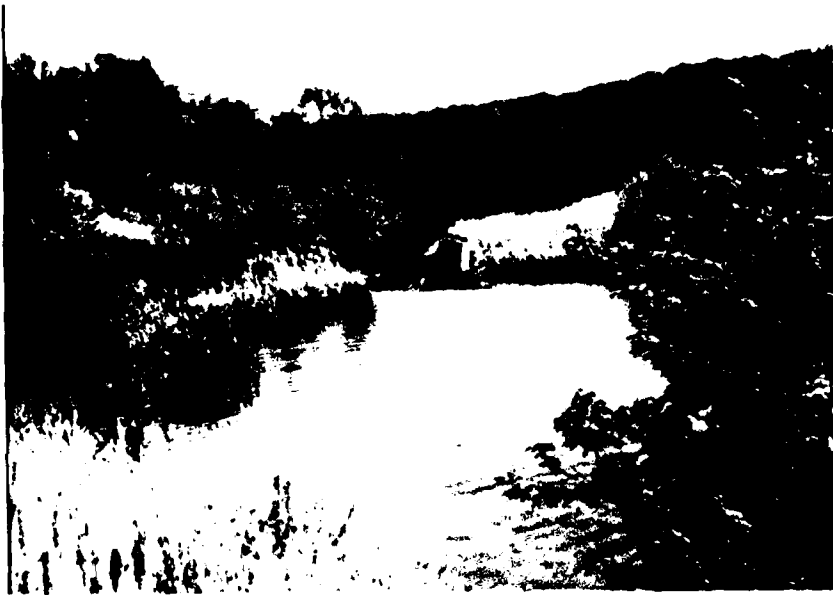
The primary and secondary principal spillway weirs indicated no signs of deterioration or erosion (see photographs No. 3 and 4, Appendix II). The discharge channel below the principal spillway exhibited erosion on the side slopes (Photograph No. 6, Appendix II and field sketch 4, Appendix III). The emergency spillway was heavily overgrown with grass and some 2 - 3 inch trees were located below the control section. Intermittent riprap failures were noted along the shoreline as a result of embankment sloughing and wave action.

Photograph No. 3 - Approach Channel and Weir

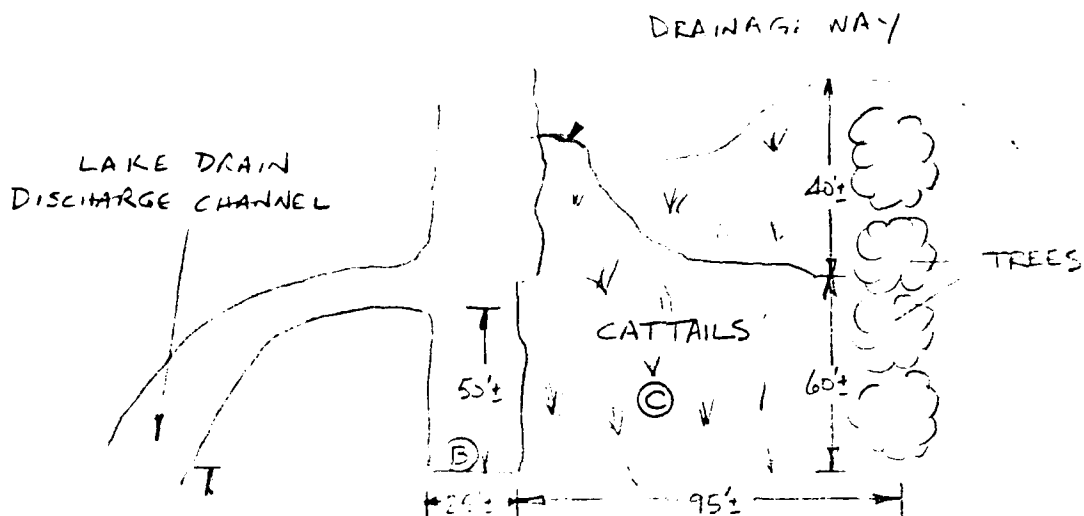
The seepage and iron staining observed below the discharge pipe is believed to be related to seepage through the dam. The strong upflow observed 115 ft to the right of the discharge pipe is believed to represent discharge from the chimney drain (described by Mr. Ritter) whose outlet is apparently covered with sediment. The iron stained area below the discharge pipe does not present a hindrance to the normal functioning of the dam, however, it is recommended this area be monitored quarterly to detect any flow which may cause piping in the embankment. If flows should occur, a Professional Engineer with expertise in Geotechnical Engineering should be contacted to evaluate the problem and make

- (A) SCATTERED IRON STAINING
- (B) 3 SMALL BOILS WITHIN 4'± DIAMETER AREA, 1 1/2'± BELOW WATER LEVEL. FLOW ESTIMATED @ 5 GPM± FROM RIGHT. THE WATER WAS CLEAR. THIS MAY BE THE CHIMNEY DRAIN OUTLET
- (C) MARSHY, SATURATED AREA LOCATED AT BASE OF RIGHT EMERGENCY SPILLWAY. NO FLOW OR IRON STAINING OBSERVED

7.3.6 Iron stained seepage present below the lake drain discharge pipe should be monitored quarterly to detect any flow. If flows should occur, a Professional Engineer with expertise in Geotechnical Engineering should be contacted to evaluate the problem and make recommendations for required corrective measures.
